Navajo Abandoned Uranium Mine

Site Screen Report

NA-0505B AUM Site

August 2010

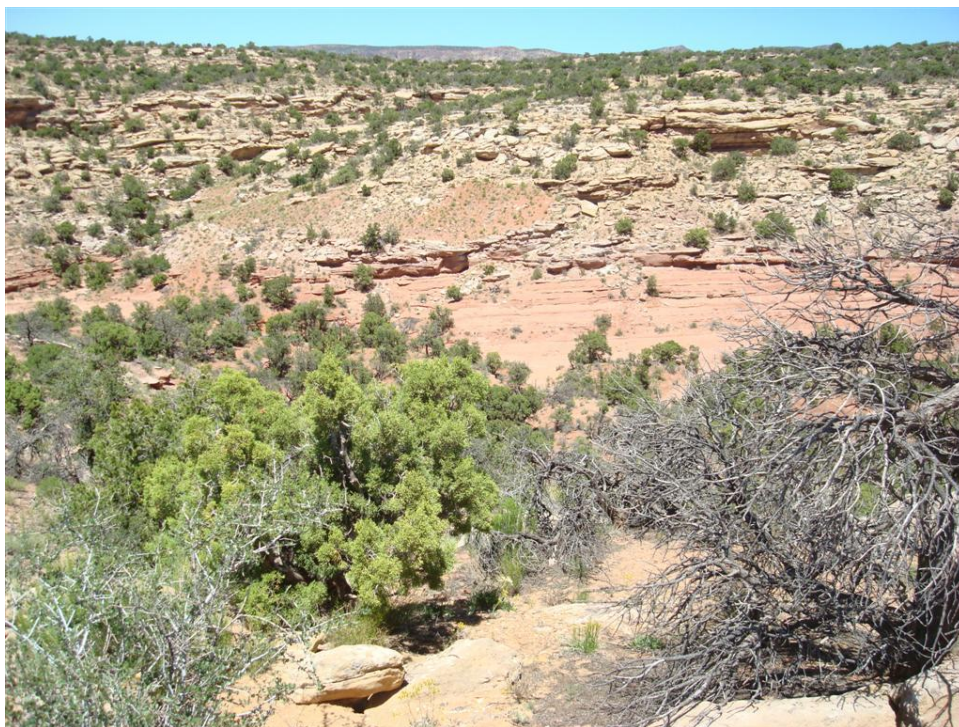
Photo 1. NA-0505B site

Small excavation pit; unreclaimed waste rock

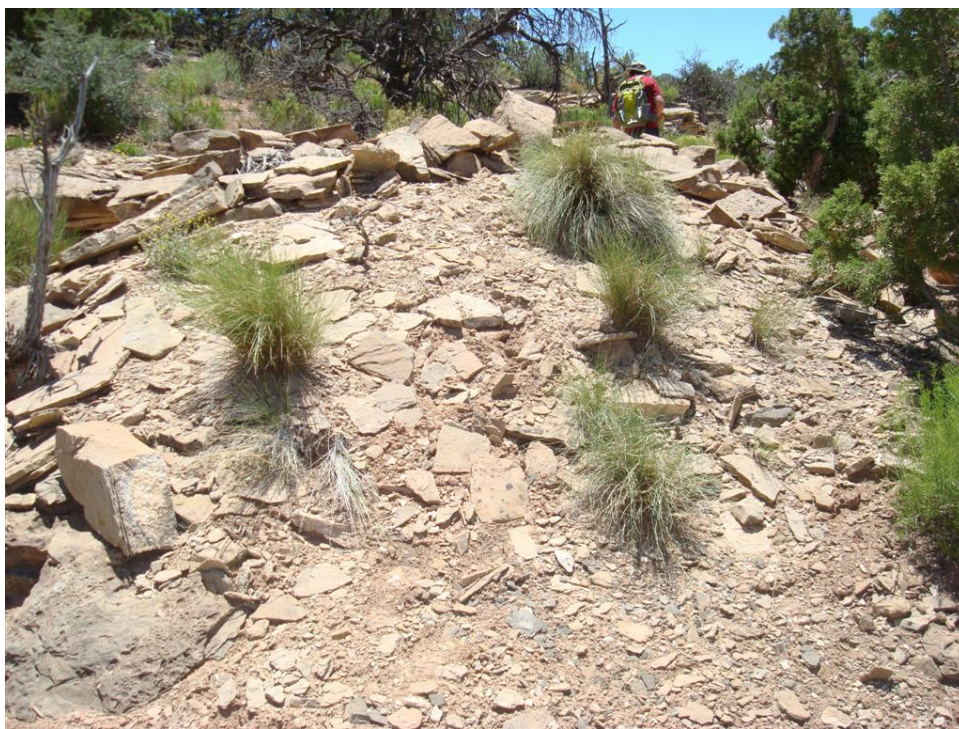
Waste pile associated with excavation pit, approximately 40 yd³

Photo 2. NA-0505B site, waste rock
